GALVANIZING IN COASTAL ENVIRONMENTS

66
galvanize
May 2008

Galvanized Steel on the Coast: Back to the Future

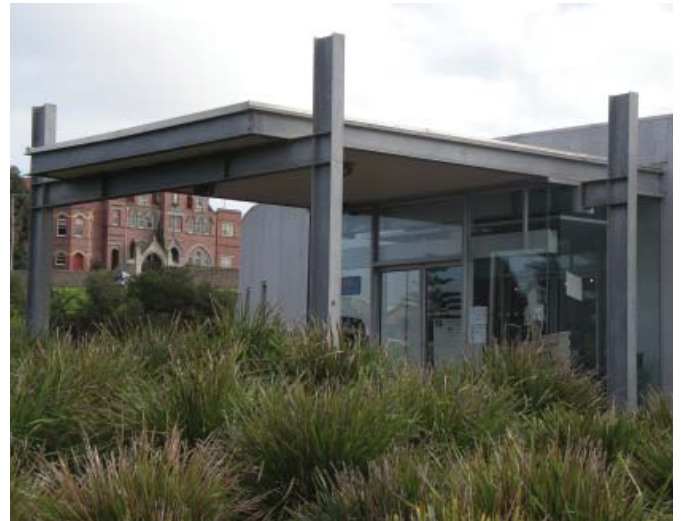
Portland Maritime Discovery Centre

The Centre is 9 years old and the galvanized steel has performed very well with no maintenance. Maintenance was a key criterion for the facility as the local authorities wanted to minimise the cost burden on the community. The design of all the steelwork took corrosion issues into consideration and this has also contributed to the performance of the galvanized steel. The corrosion protection integrity of the structure was maintained through the bolting of joints, welding prior to galvanizing and consideration of bimetallic corrosion.

After 9 years, the average coating thickness of the structural steel is 2 to 3 times (160 – 220 µm) the required level of AS/NZS 4680.

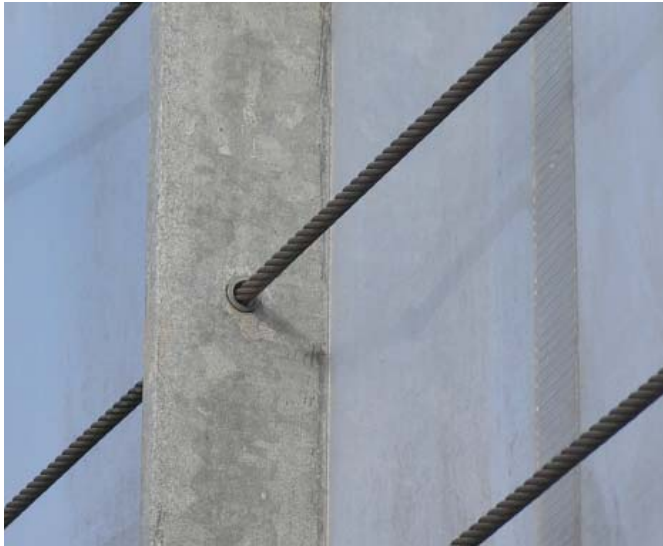
Use of plastic inserts prevents dissimilar corrosion between stainless steel and galvanized steel in coastal environment

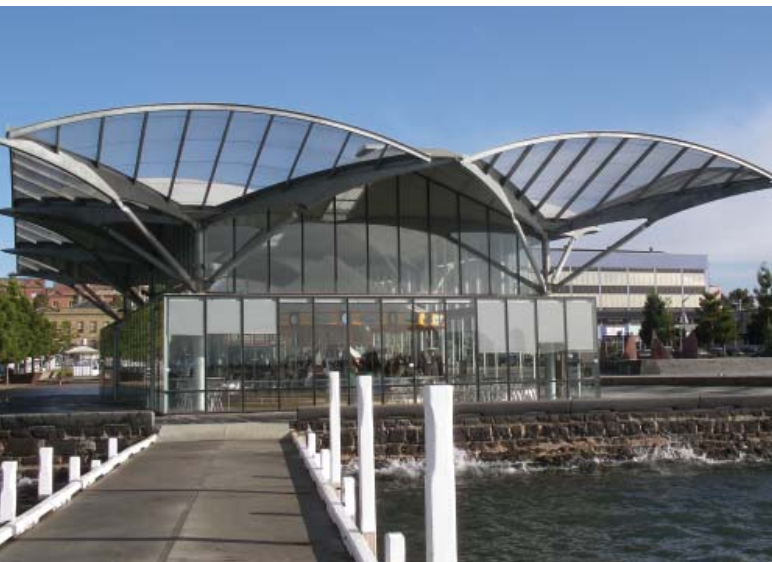
All of the structural steel in the Pavilion is hot dip galvanized steel and most of it is exposed to the sea. An indication of the potential for significant chloride deposition is that one of the major structural design parameters for the building was the offshore wind loading. The design of the structure paid due consideration to corrosion through the use of bolting, the minimization of “corrosion hotspots” due to proper detailing and the expanded metal roofing that reduced the wind loading and allowed the washing effects of rain on external steelwork.

Geelong Carousel Pavilion

The carousel is a popular tourist attraction and during school holidays it is subject to considerable stress due to children’s parties and general public traffic. It has been open for 6 years and has required no maintenance in that time. The steelwork is in excellent condition and all of the galvanizing is 2 to 3 times in excess of the levels required by AS/NZS 4680.

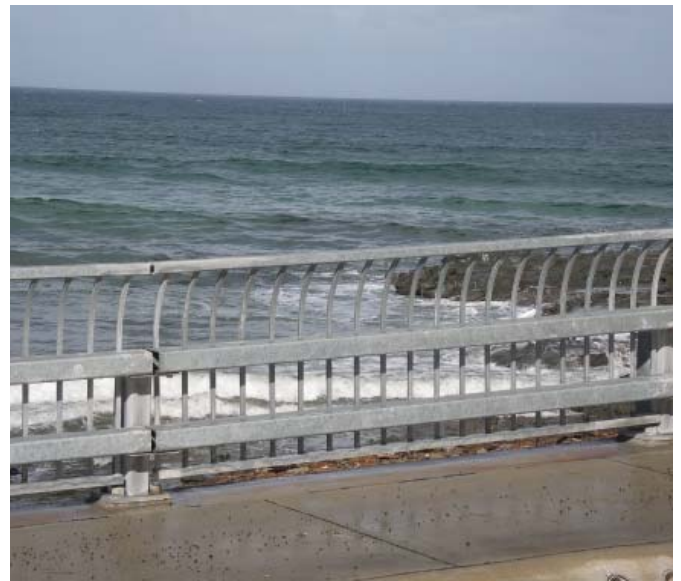
12 bridge rails were examined along the Great Ocean Road on the south-west of Victoria with the assistance of the local roads authority. All of the bridge rails were performing well and it is standard for them to be hot dip galvanized and either left bare or painted in instances where aesthetic requirements demanded. Of interest is the fact that even though many of the bridge rails were in the surf zone and approximately 10 – 30m from the breaking surf and over estuarine waters, they were in excellent condition. Conferral with the responsible engineers indicated that they were performing as expected and that a life of over 20 years with minimal maintenance was the expected performance.

Bridge rail at Smythes Creek on Great Ocean Road (10 years old)

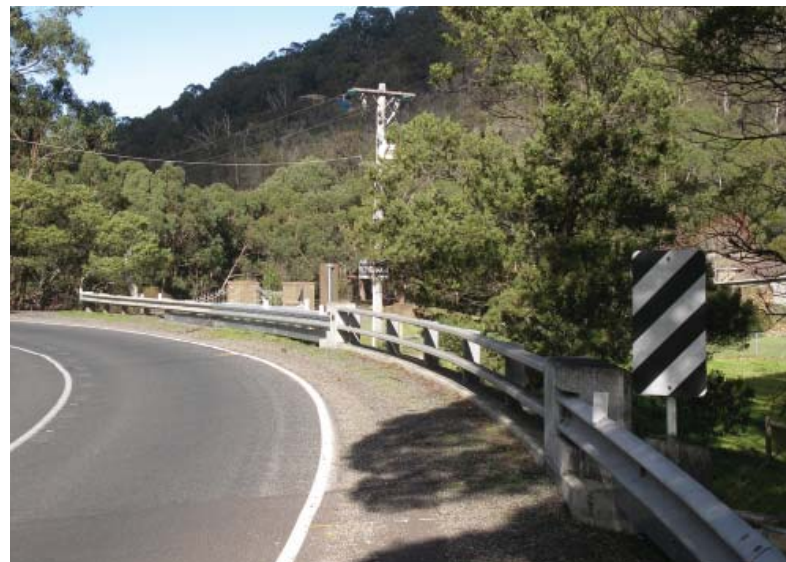
Bridge rail at Grassy Creek on Great Ocean Road (24 years old)

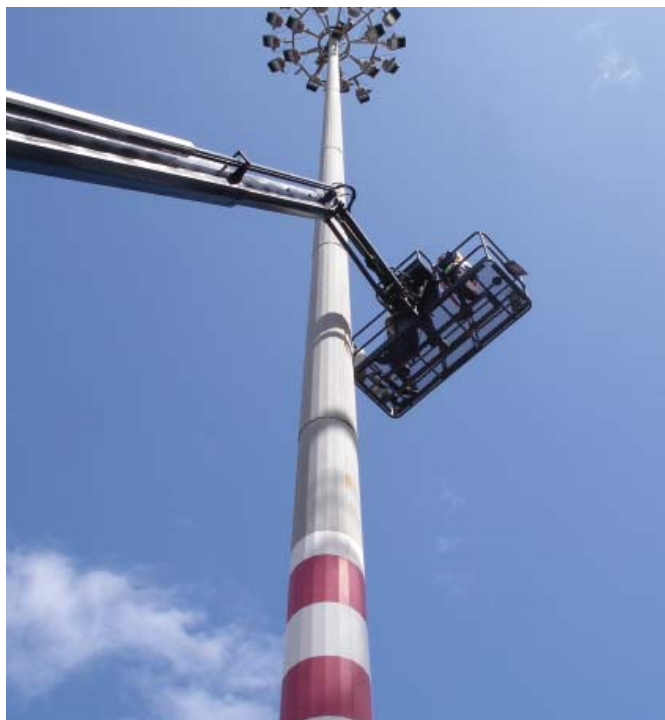
Port of Botany light tower being examined (27 years old)

The DP World terminal is located in Botany Bay. Depending on wind levels, water agitation and other factors, then the corrosivity environment may be classed as either a C: Medium to AS/NZS 2312 (C3 ISO 9223) or D: High (C4 ISO 9223). During the time of the inspections, the wind was very strong coming off the bay and there was considerable spray indicating that for certain weather conditions there would be periods where the environment approaches that of an E-M Very High Marine (C5 ISO 9223).

The coating appeared to be in good condition considering its exposure environment and age of 27 years. All of the thickness measurements were above what would be required by Australian Standards for a new installation (AS/NZS 4680).

Based on the conventionally accepted corrosion rates for zinc and taking into account the lowest measured thicknesses for each tower, it was conservatively determined that the remaining life of the coating was approaching at least 20 to 25 years.
