# galvanize November 2013

# RAIL EXTENSION PUSHES BOUNDARIES

### GALVANIZED FINISH GUARDS NEW RAIL WORK

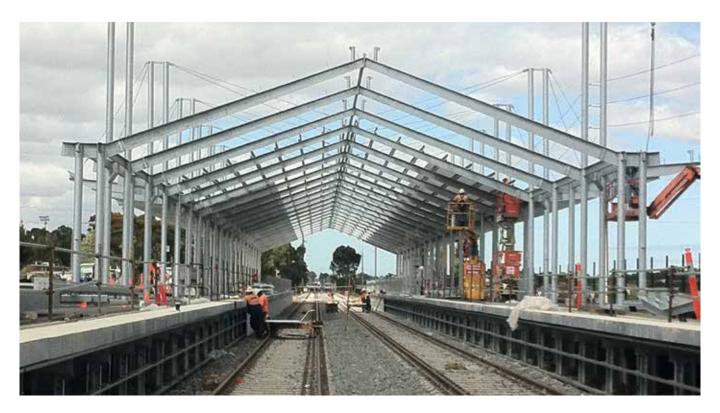
They said the winning Korvest Galvanisers entry scored highly on its market development potential and technical innovation by demonstrating that a high quality hot dip galvanized (HDG) coating can be applied to oversize assemblies without coating blemishes or distortion.

The fully enclosed pedestrian overpasses, lift towers and enclosed stairs for each station required early intervention to ensure they could be broken down efficiently to enable HDG. Segments were up to 3.6 to 3.8 metres high, up to 10 metres long and weighed up to five tonnes, thus comprising large double dips.

Once fabrication commenced, the galvanizer was in constant contact with the fabricators, particularly with respect to the draining and venting of the large rectangular hollow section frame segments for the pedestrian overpasses, lift towers and access stairs. Initial concerns over the adequacy of shop repair when welding the segments together were allayed with the assistance of the GAA technical note on this topic.

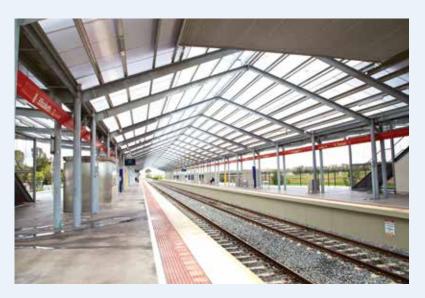
Across the four rail stations a total of 850 tonnes of structural steelwork was galvanized comprising platform canopies and heavy pedestrian overpasses, lift towers and access stairs as well as ancillary steelwork including sign gantries over the rail tracks, lighting towers, bike sheds and decorative screens.

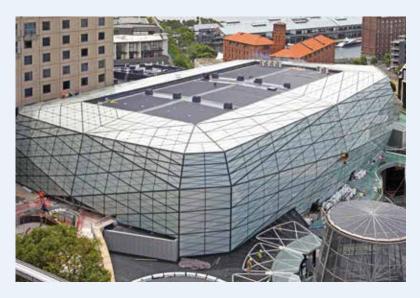
The MUEF is a 40 by 60 metre complex geometric structure that utilises a 300-tonne galvanized steel frame to support internal walls and an external glass façade which is internally lit at night to spectacular effect.

Aesthetics were a key consideration in the selection of HDG as the steel frame is visible through the glass façade which is exposed to sunlight as well as at internal locations. Despite the filtering effect of the glass, impact of UV light on the coating had to be considered and HDG is not affected by UV. Galvanized steel quality was important including placement and precision of vent and drain holes.

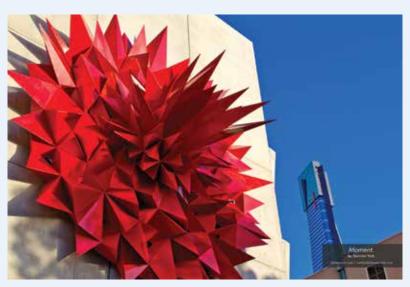
The result is a striking HDG and painted piece seven metres in diameter by 2.4 metres deep permanently installed five metres above ground. Predominantly created from 3mm mild steel and mounted on an angle frame, the installation weighs three tonnes.

Due to the complexity of the design, the structure was created from 49 individual sections with every piece hot dip galvanized; the finish primarily chosen over a paint-only application to ensure longevity. The HDG coating under the aesthetic paint means that the steel substrate will not corrode and taint the work with unsightly rust staining.

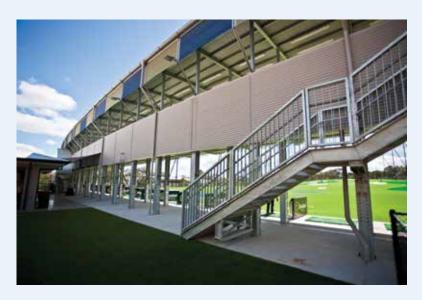
The structure therefore incorporates a system to adjust deck levels and a lightweight HDG steel superstructure was chosen. HDG was applied to the entire two tiers of the structure, comprising 80 tonnes of structural steel portal frame supporting a steel clad roof and two levels of pre-cast concrete flooring.

The HDG structural steelwork includes universal beams and columns, parallel flange channels as well as rectangular and circular hollow sections
